## OBSERVATIONS OF PROPAGATING STALL IN AXIAL-FLOW COMPRESSORS

T. Iura and W. D. Rannie

Report No. 4

April 1953

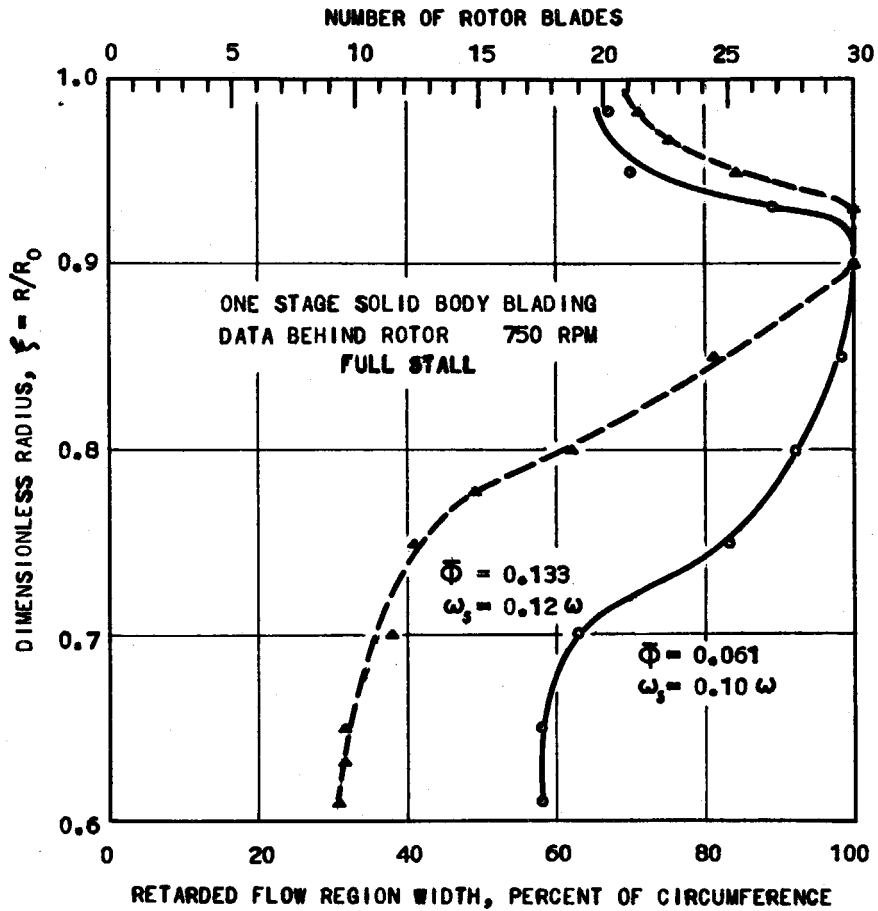
FIGURE 44  
RADIAL VARIATION OF RETARDED FLOW REGION WIDTH
